ADHESIVE BONDED AEROSPACE STRUCTURES STANDARDIZED REPAIR HANDBOOK

BOEING COMMERCIAL AIRPLANE COMPANY
P.O. BOX 3707
SEATTLE, WASHINGTON 98124

MAY 1976

PHASE III REPORT FOR PERIOD 1 JANUARY 1975 THROUGH 30 SEPTEMBER 1975

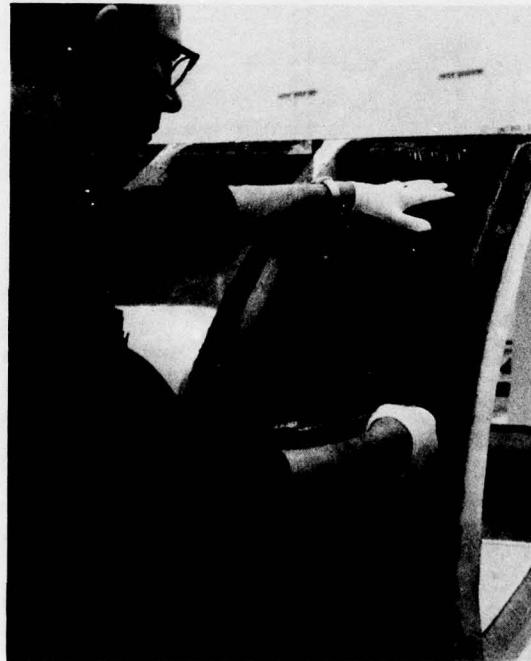
Figure 28.—Application of EC3921 Adhesive Primer Using a Preval Power Unit

Figure 29.—Application of AF127-3 Adhesive Film

The cleaned surfaces are shown being primed in figure 28. The primer is EC3921. Application was with a Preval power unit and container. Application of the AF127-3 adhesive film is shown in figure 29.

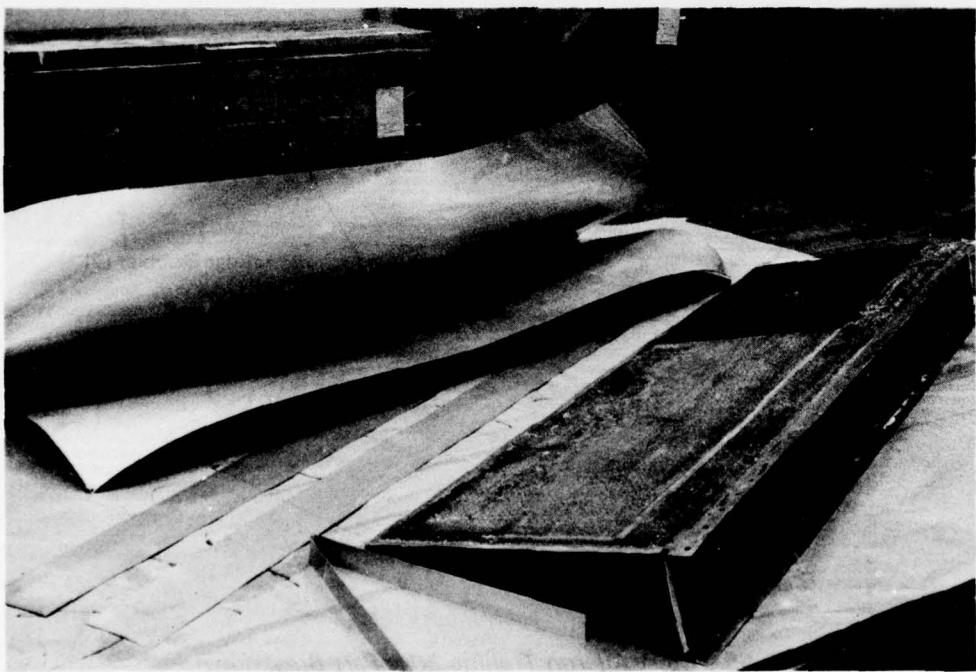
The bond areas on the part had a coating of the original adhesive. This was lightly sanded and wiped with MEK. The details were then primed and the part assembled for bonding. The primer was EC3921, and the adhesive was AF127-3. The part details are shown ready for assembly in figure 67.

Figure 67.—C5-A Aileron Trailing Edge Repair Details Ready for Bonding

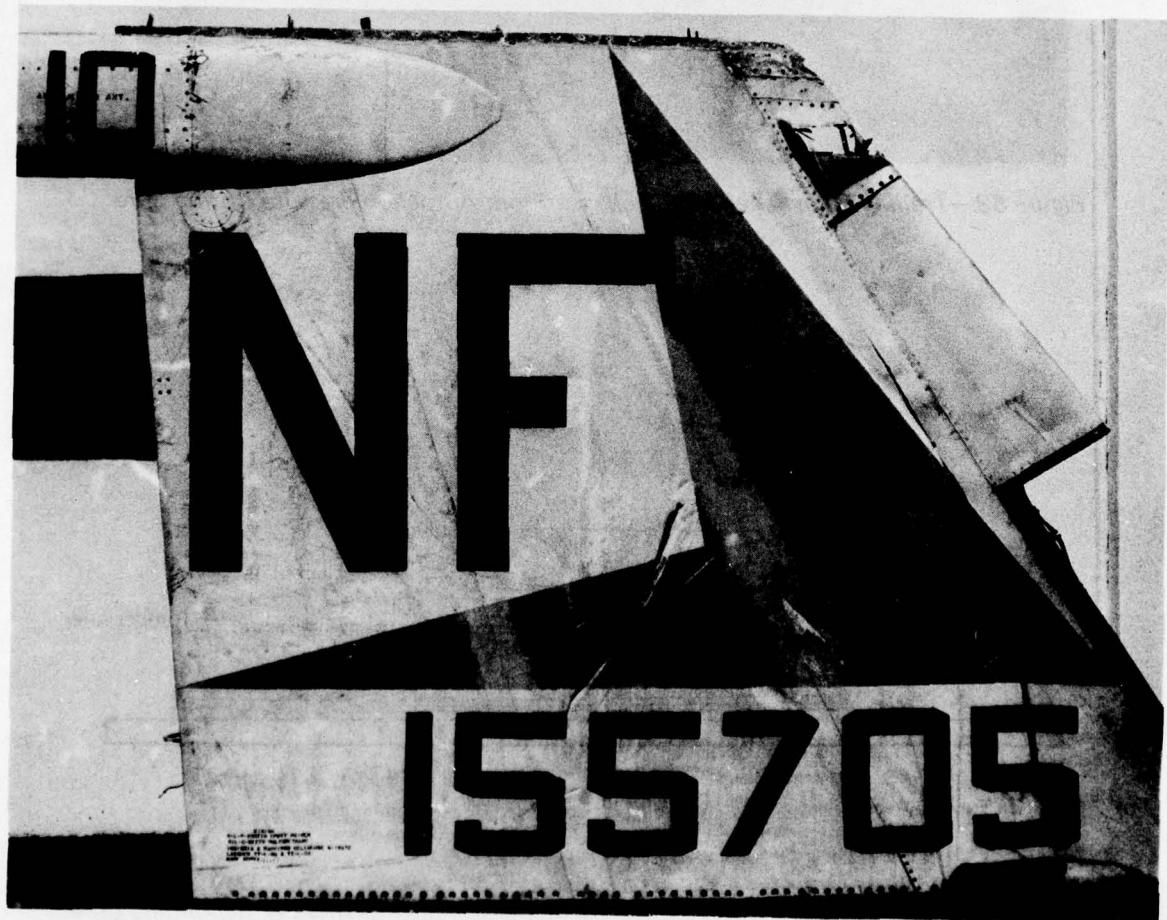
Figure 71.—Damaged A-6 Vertical Fin Received From the Norfolk Naval Air Station

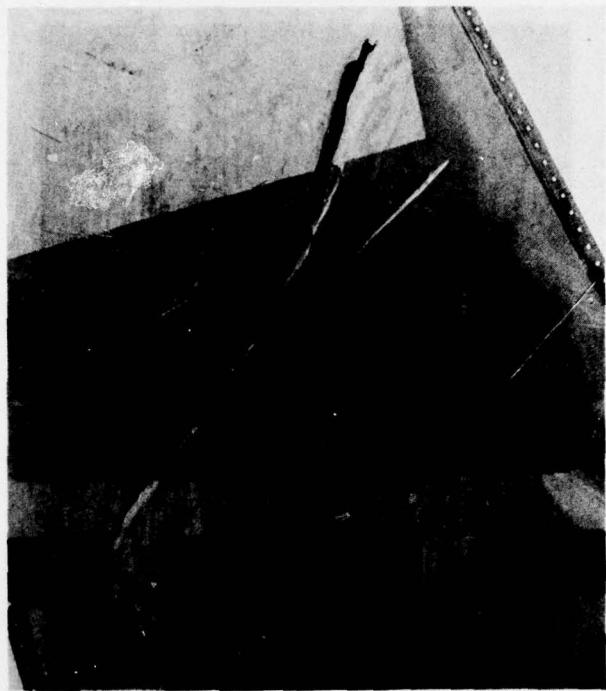
Figure 72.—Closeup of Damage to the A-6 Fin Panel Exterior Surface
